**NFI and Emergency Shelter
DISTRIBUTION REPORT/Shelter Construction**

Report Date: 10 th of June 2017	Shelter construction Date(s): 19 th of May 2017 to 26 th of May 2017
Pipeline Request Reference <i>(if the distributed items comes from pipeline)</i>	WAU – IOM – WAU – R - 0712

Distribution Location Information	
State*	Western Bahr El Ghazal
County*	Wau
Payam*	Wau North
Exact location/Boma*	POCAA, Cathedral Church, Loko Loko
GPS Coordinates	
Site/settlement Type*	PoCAA <input checked="" type="checkbox"/> Collective Centres <input checked="" type="checkbox"/> Others (specify) _____ <input type="checkbox"/>
Displacement Type*	Conflict affected <input checked="" type="checkbox"/> Disaster affected <input type="checkbox"/> Other (Specify) _____ <input type="checkbox"/>

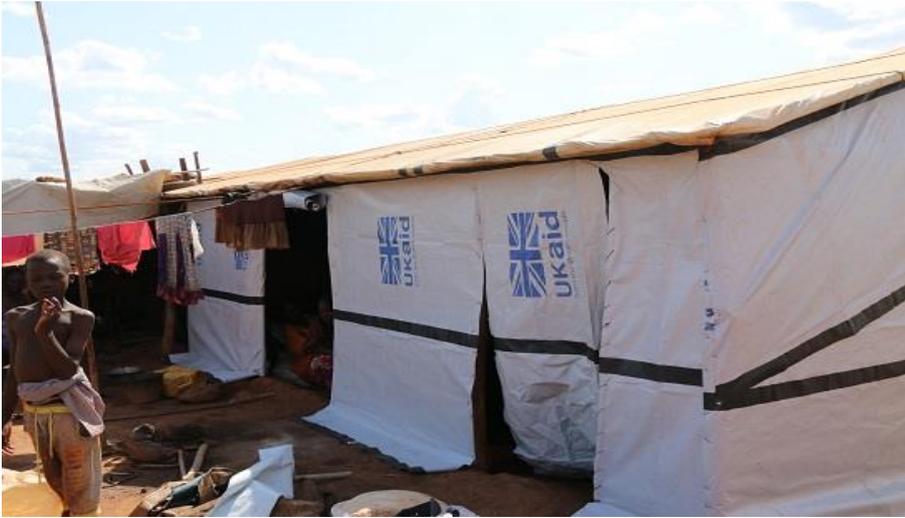
Communal shelter in the PoC

There were some specific shelters which required replacement for the whole plastic sheeting and reinforcement of the structure with bamboos, nails and rubber ropes; while others that need only some plastic sheets to support the roof or the sides.

The communal shelters in the PoC were affected by people's misuse to put fire wood and bamboos on the shelter's roof. This issue has been discussed during a meeting with community leaders, in order to be communicated to the IDPs.

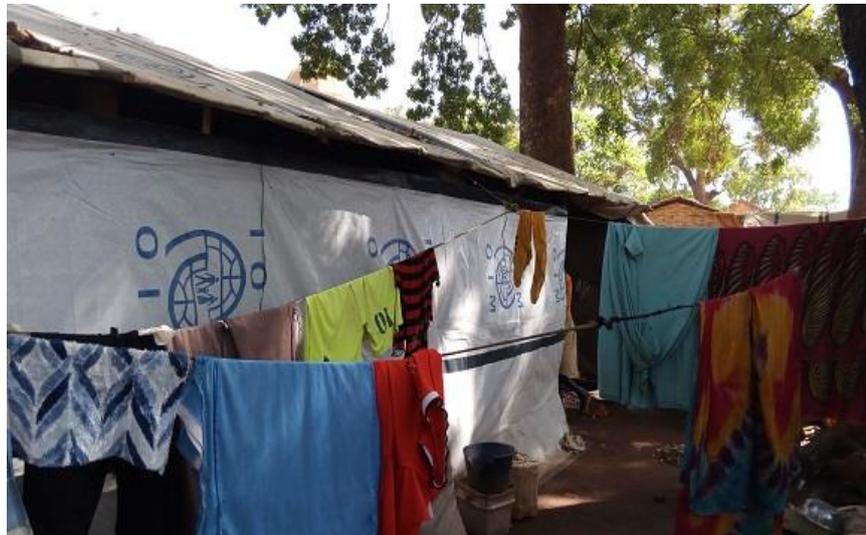
Communal shelter in the Cathedral
